# VEHICLE INSPECTION REPORT

**HK71PXU**

## Ford Transit 350 2.0 ECOBLUE 130PS

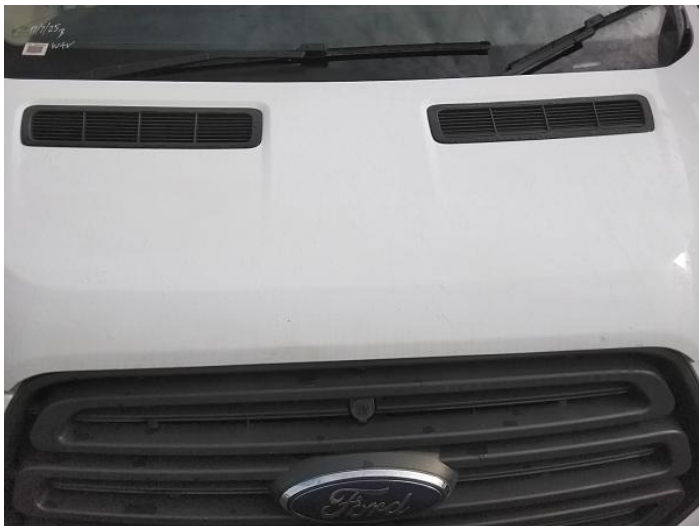
1: Bonnet  
Chipped  
Multiple Chips

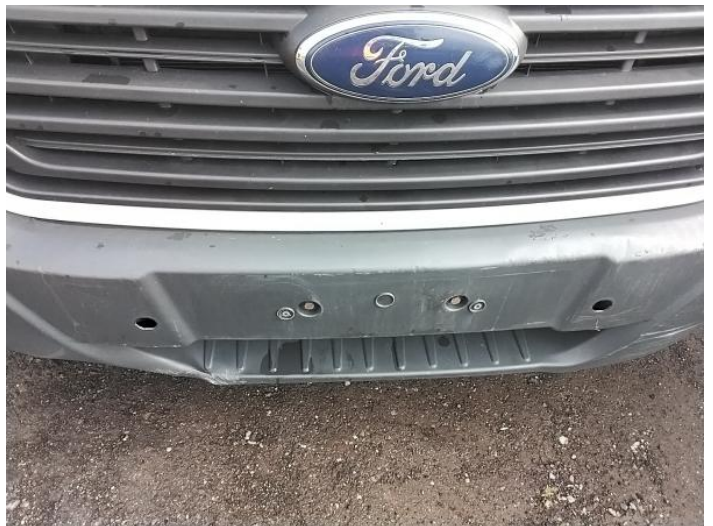
2: Number Plate Front  
Missing  
Replace

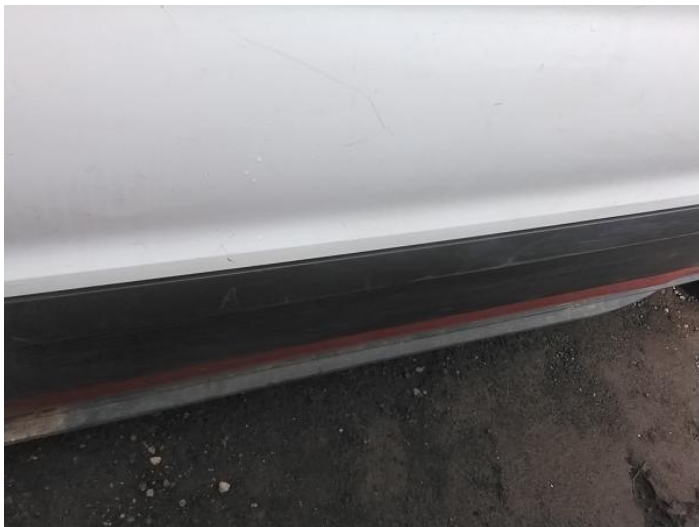
15: Qtr Panel Moulding ns  
Scuffed (Unpainted)  
Over 100mm

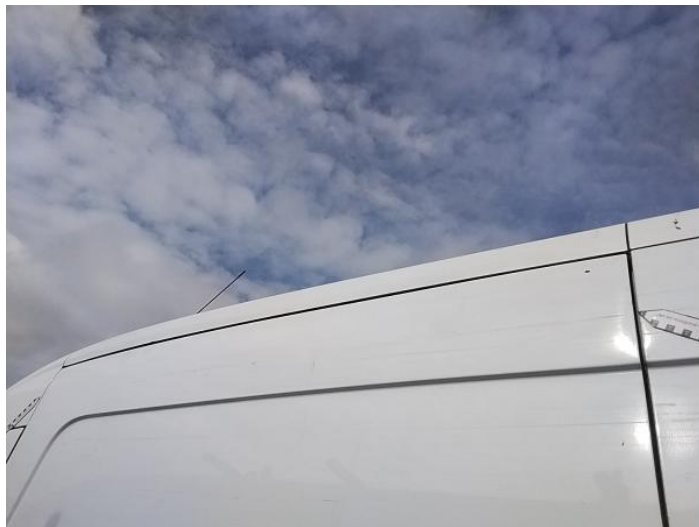
16: Qtr Panel nsr  
Scratched  
Over 25mm Thru Paint

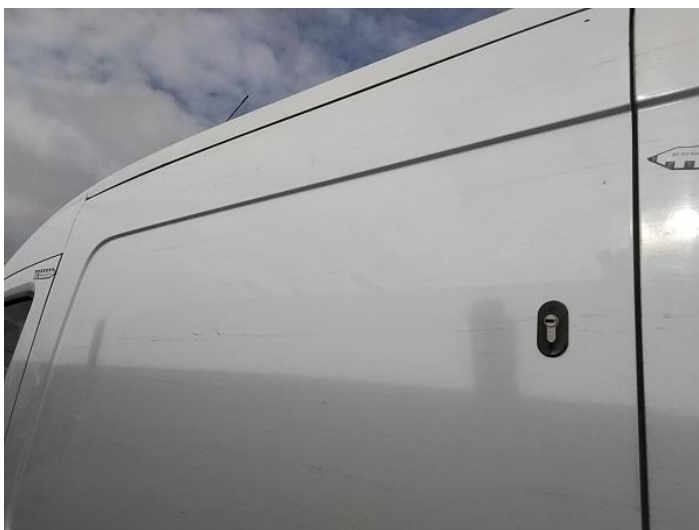
17: Qtr Panel nsr  
Scratched  
Over 25mm Thru Paint

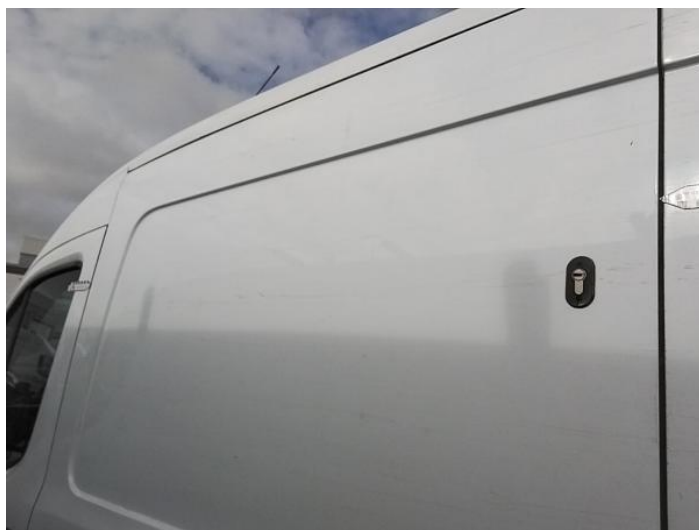
18: Qtr Panel nsr  
Scratched  
Over 25mm Thru Paint

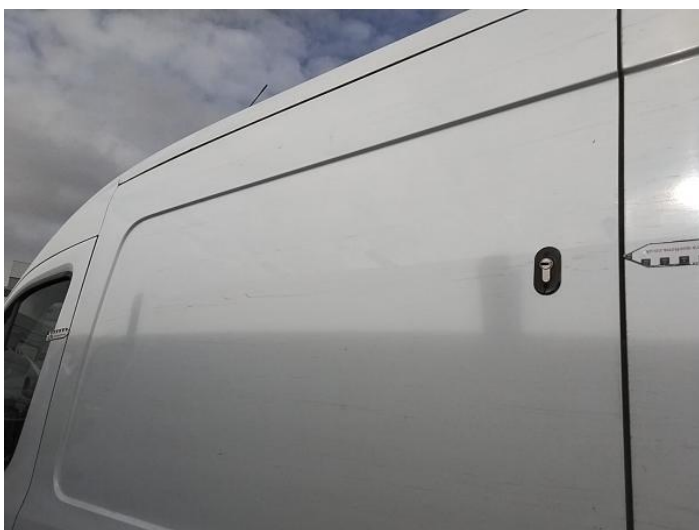
19: Qtr Panel nsr  
Scratched  
Over 25mm Thru Paint

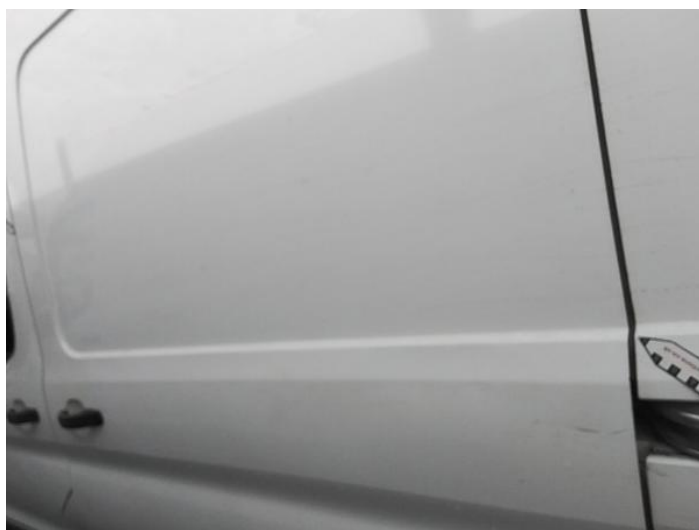
20: Qtr Panel nsr  
Scratched  
Over 25mm Thru Paint

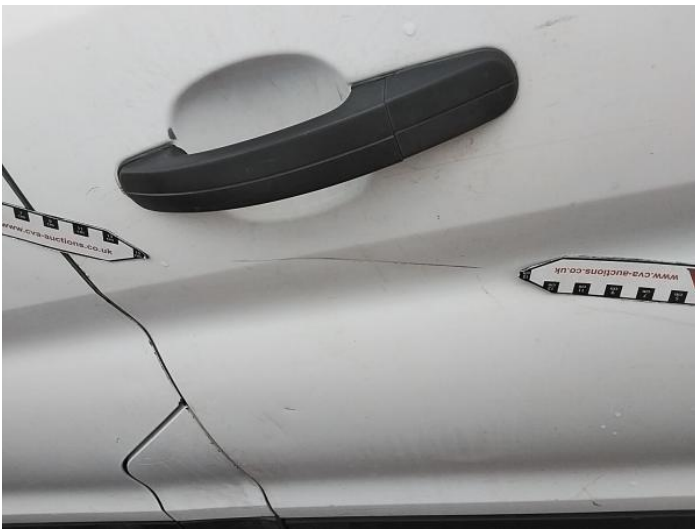
23: Qtr Panel nsr  
Dented  
With Paint Damage

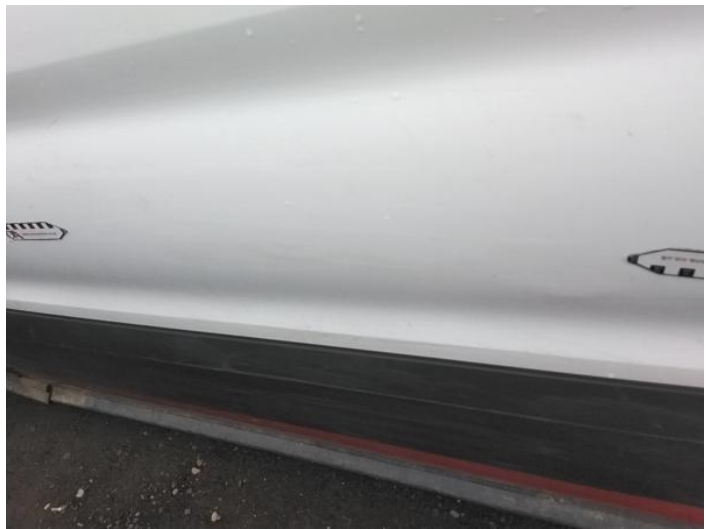
24: Qtr Panel nsr  
Scratched  
Over 25mm Thru Paint

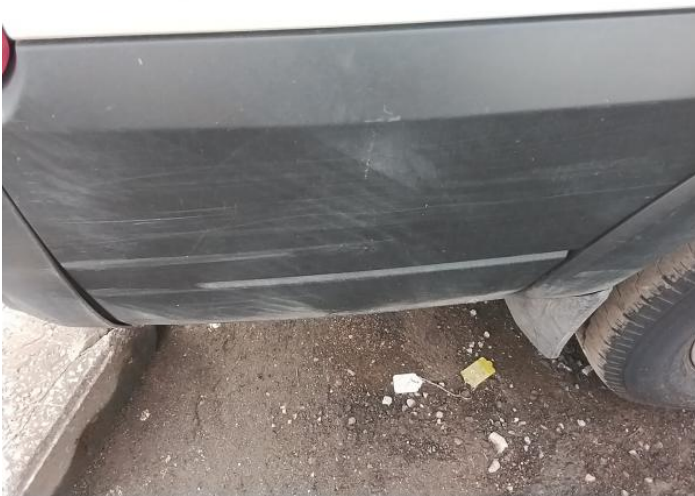
43: Qtr Panel Moulding os  
Scuffed (Unpainted)  
Over 100mm

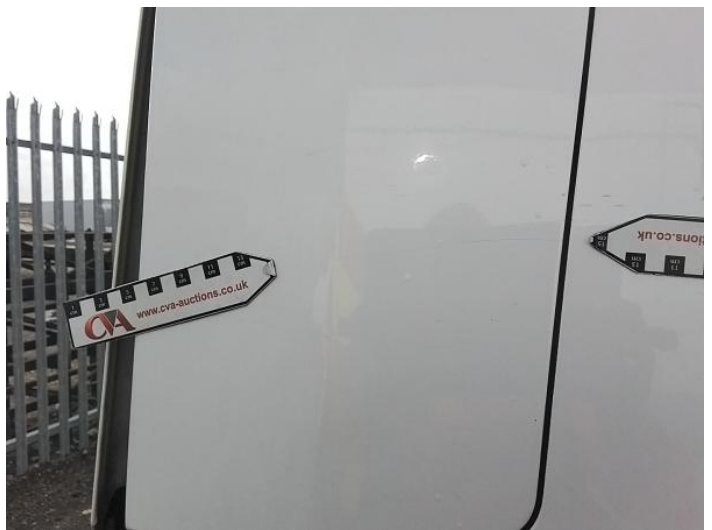
44: C Post os  
Scratched  
Over 25mm Thru Paint

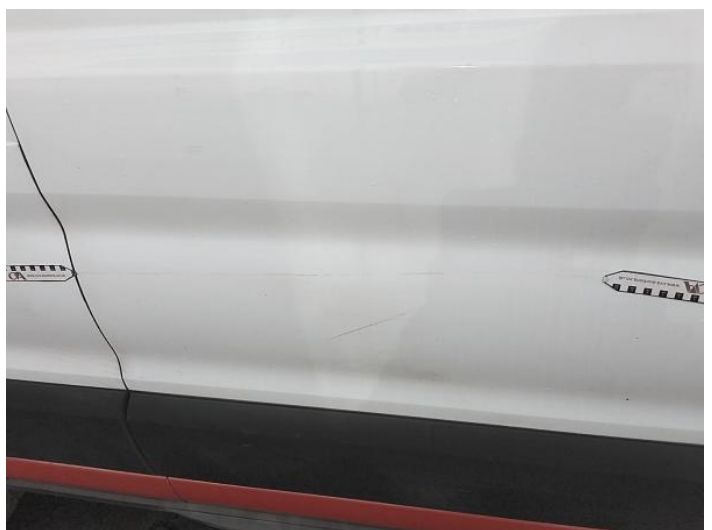
50: Qtr Panel osr  
Scratched  
Over 25mm Thru Paint

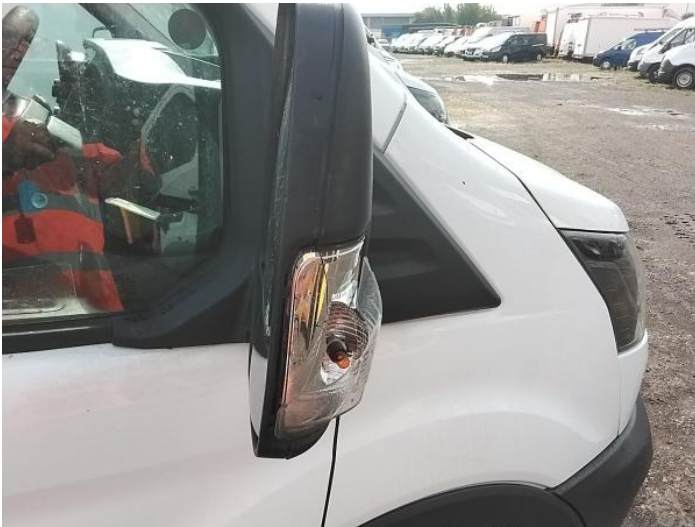
53: Door Mirror Assy osf  
Broken  
Replace

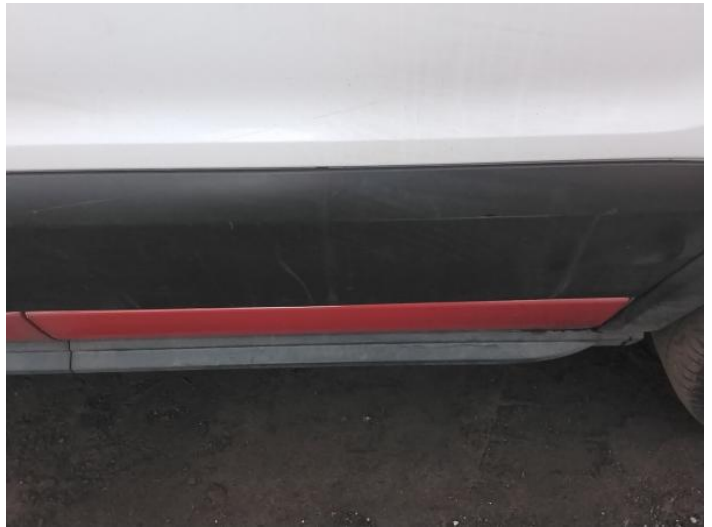
54: Door Moulding osf  
Scuffed (Unpainted)  
Over 100mm
