# VEHICLE INSPECTION REPORT

**WJ64BZY**

## ISUZU D-MAX 2.5TD TURBO

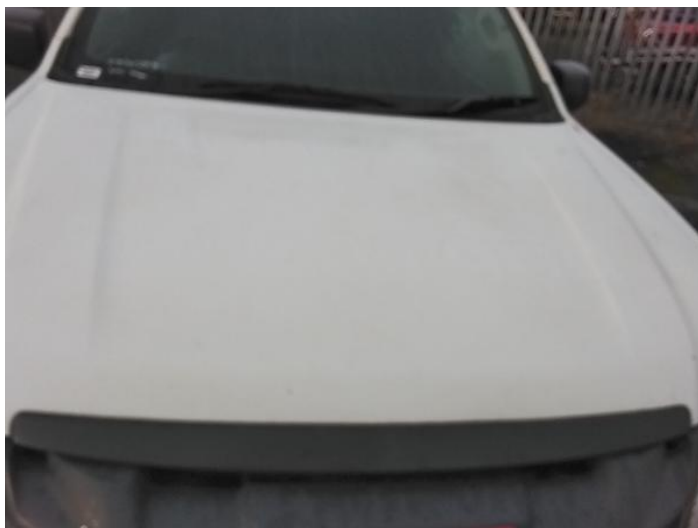
1: Bonnet  
Chipped  
Multiple Chips

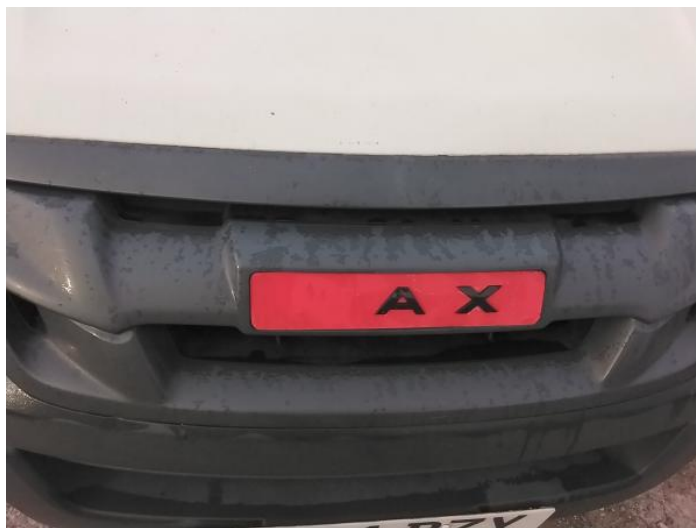
2: Badgedecal Front  
Missing  
Replace

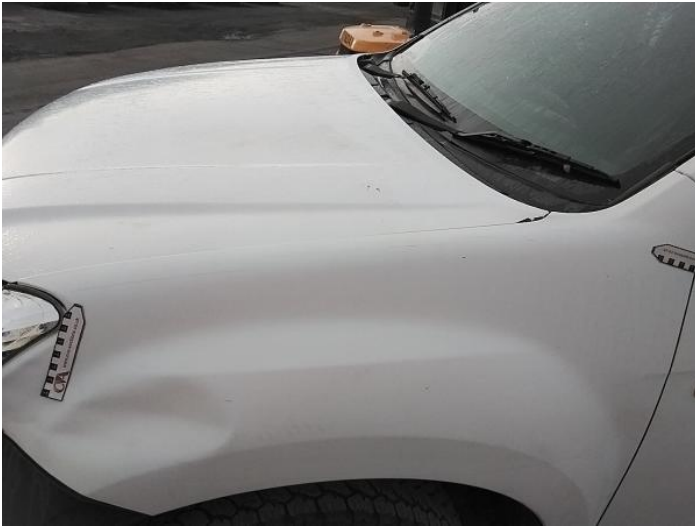
3: Wing nsf  
Scratched  
Over 25mm Thru Paint

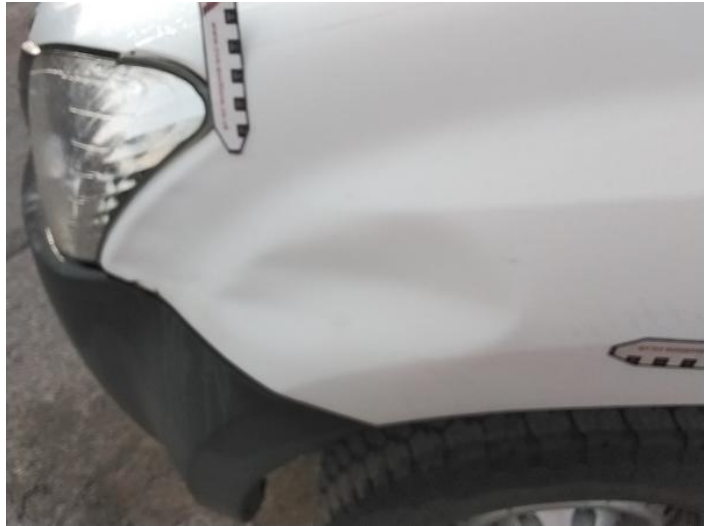
4: Wing nsf  
Dented  
Over 30mm

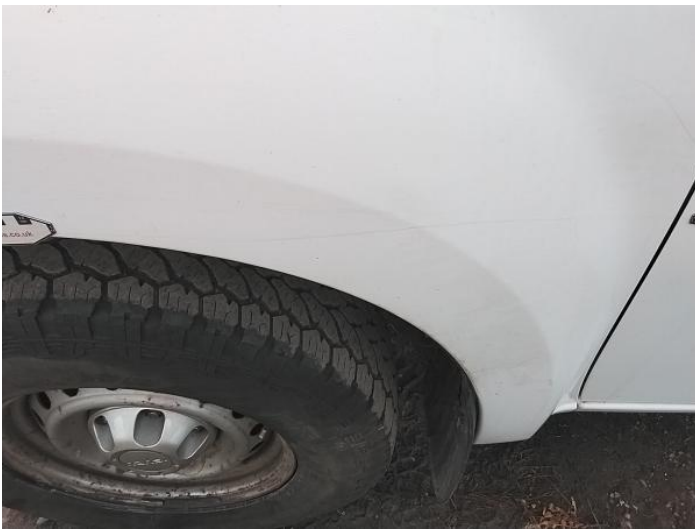
5: Wing nsf  
Scratched  
Over 25mm Thru Paint

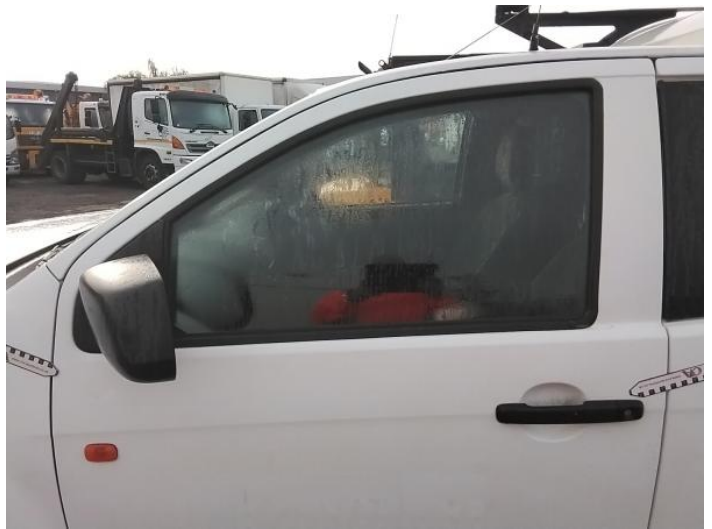
6: Door nsf  
Scratched  
Over 25mm Not Thru Paint

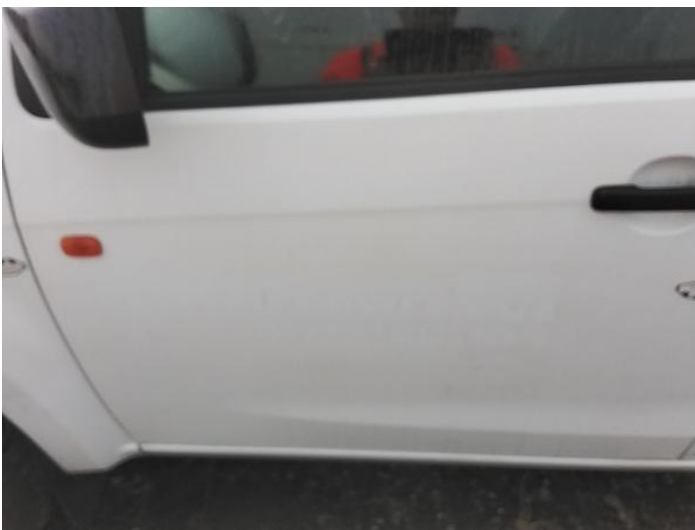
7: Door nsf  
Scratched  
Over 25mm Not Thru Paint

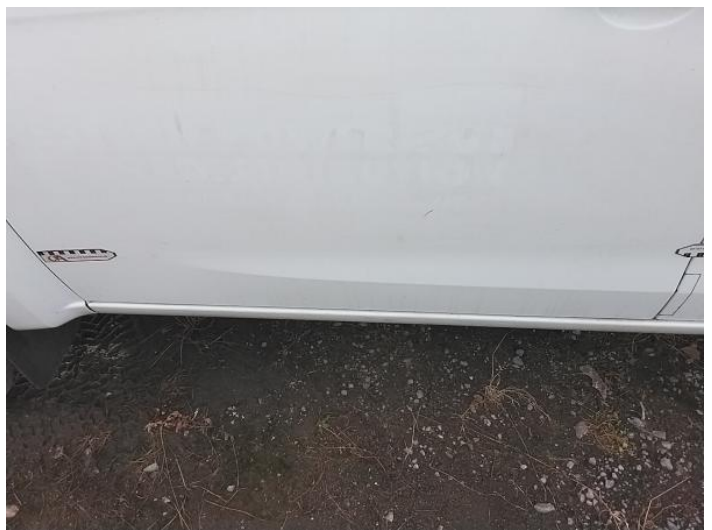
8: Door nsf  
Scratched  
Over 25mm Thru Paint

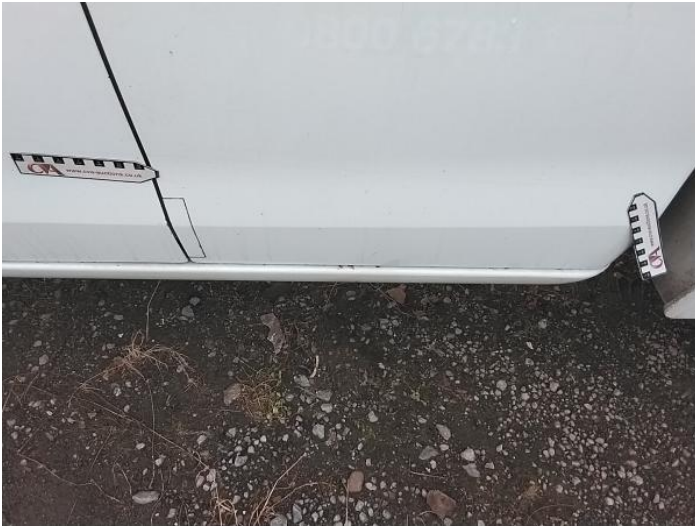
9: Qtr Panel nsr  
Scratched  
Over 25mm Thru Paint

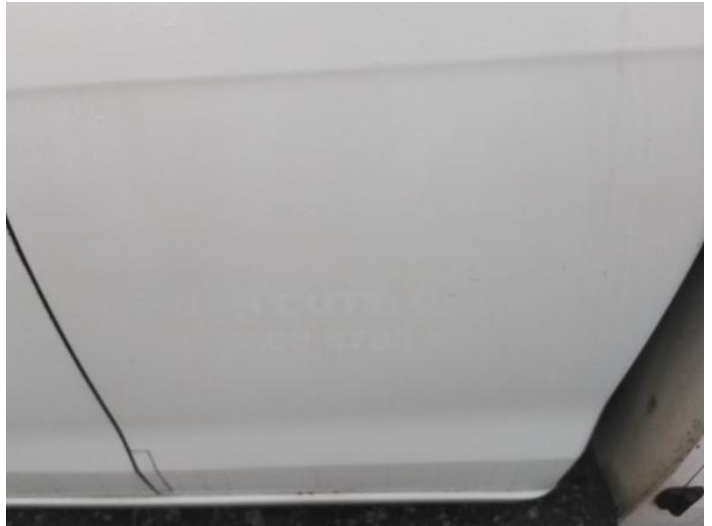
10: Qtr Panel nsr  
Chipped  
Multiple Chips

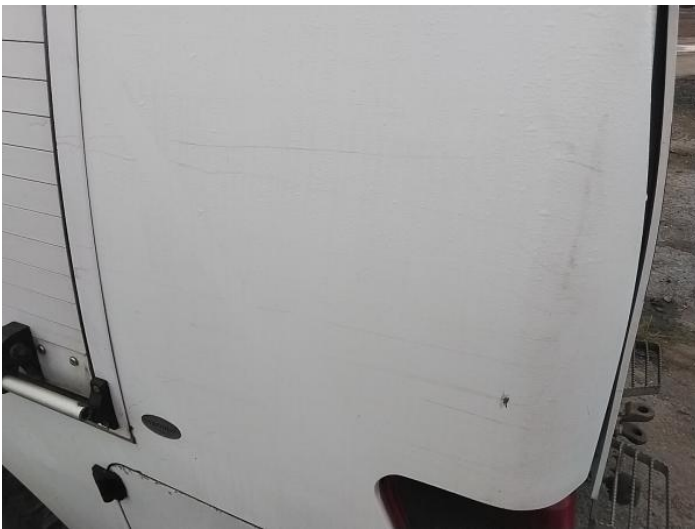
11: Qtr Panel nsr  
Scratched  
Over 25mm Thru Paint

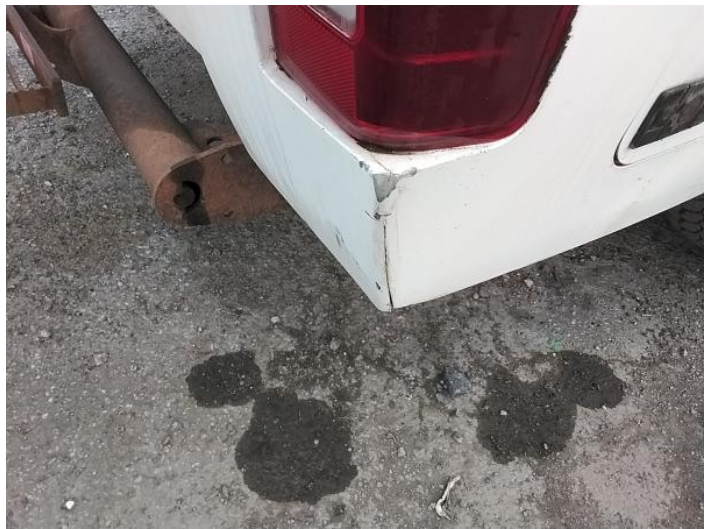
12: Qtr Panel osr  
Cracked  
Replace

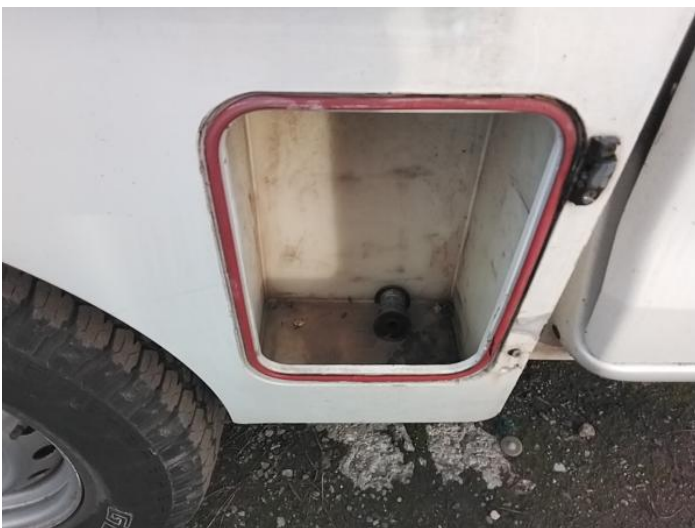
13: Qtr Panel Moulding os  
Missing  
Replace

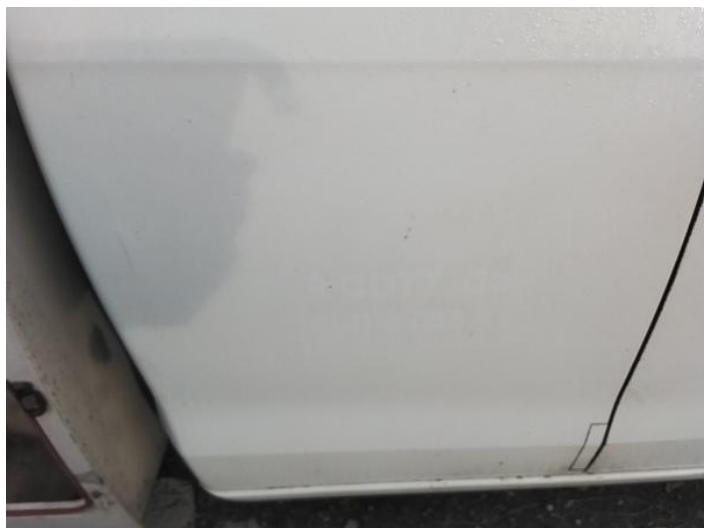
14: Qtr Panel osr  
Chipped  
Multiple Chips

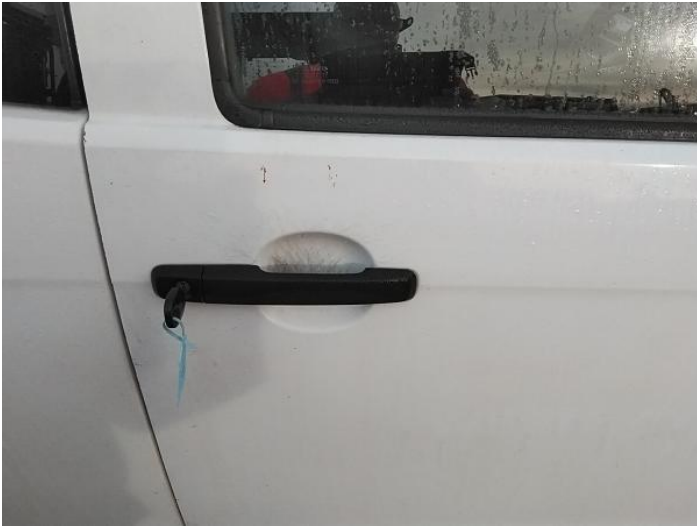
15: Door osf  
Chipped  
Multiple Chips

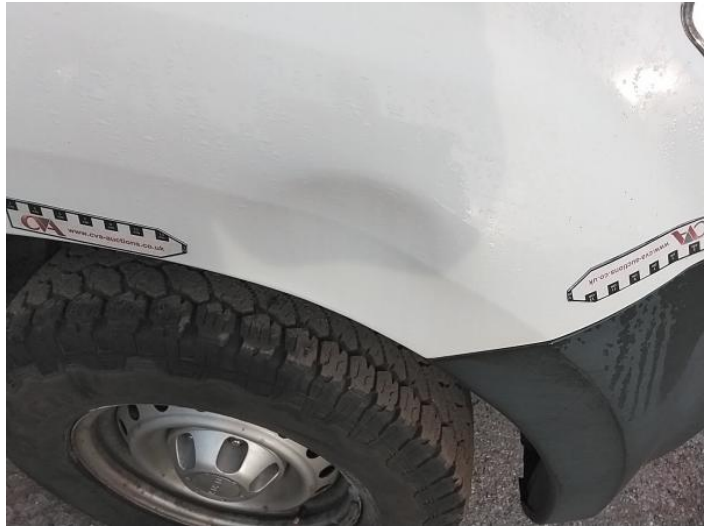
16: Wing osf  
Dented  
Over 30mm

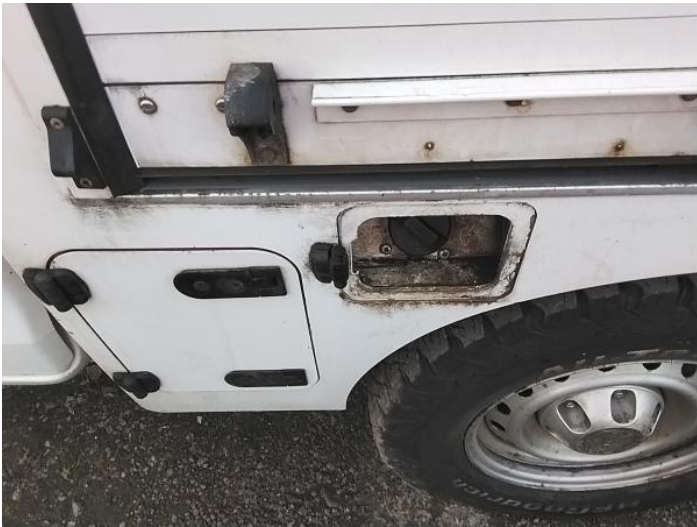
17: Fuel Flap  
Missing  
Replace

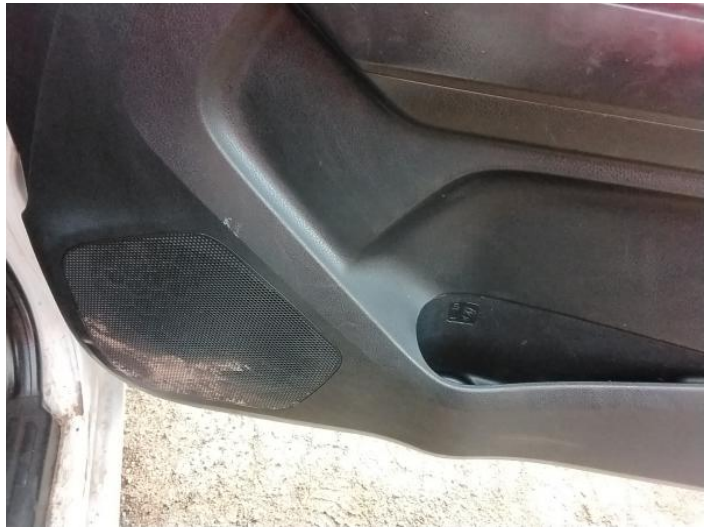
18: Door Pad osf  
Soiled  
Heavy

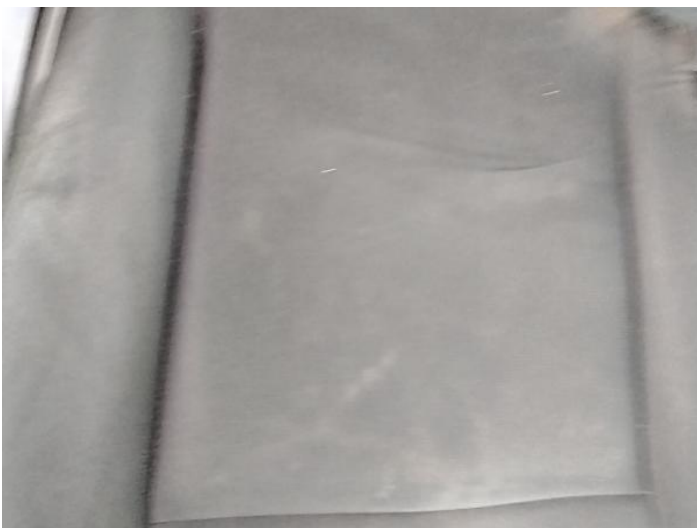
19: Seat Base Cover osf  
Soiled  
Heavy

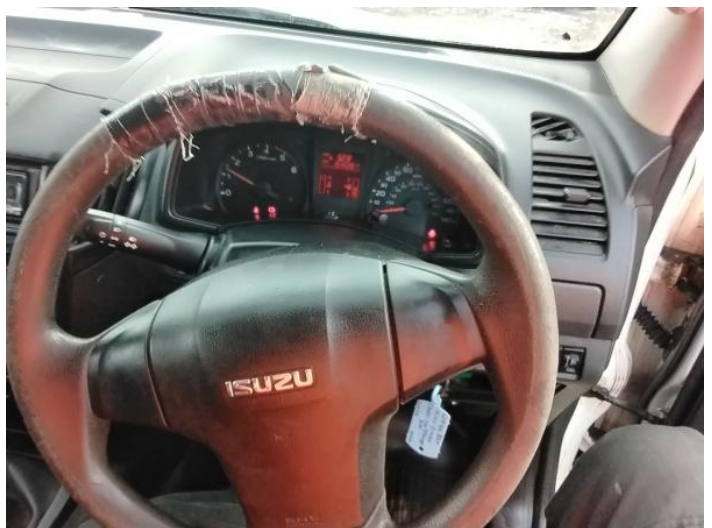
20: Steering Wheel  
Damaged  
Replace

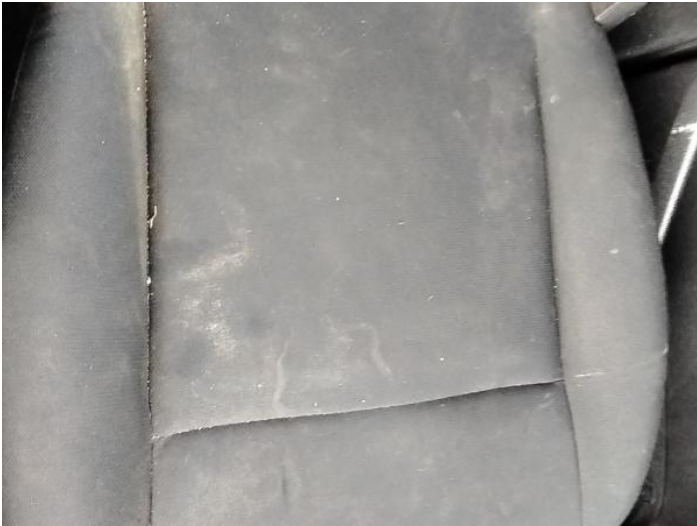
21: Seat Base Cover nsf  
Soiled  
Heavy

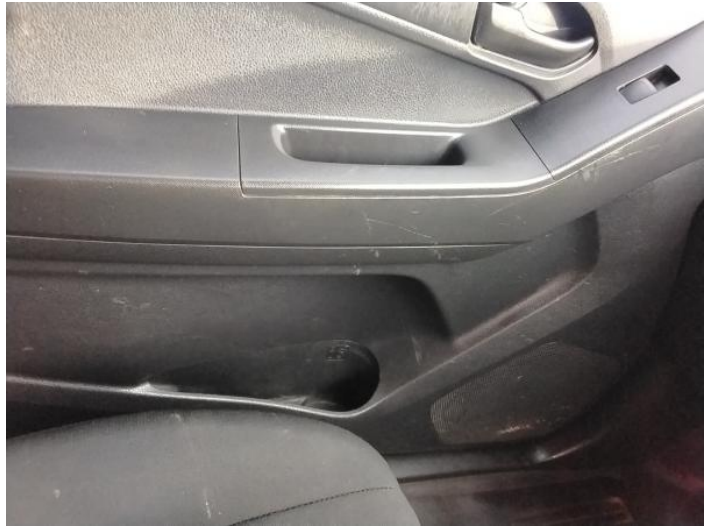
22: Door Pad nsf  
Scuffed  
Over 25mm
