# VEHICLE INSPECTION REPORT

**HK71PXU**

## Ford Transit 350 2.0 ECOBLUE 130PS

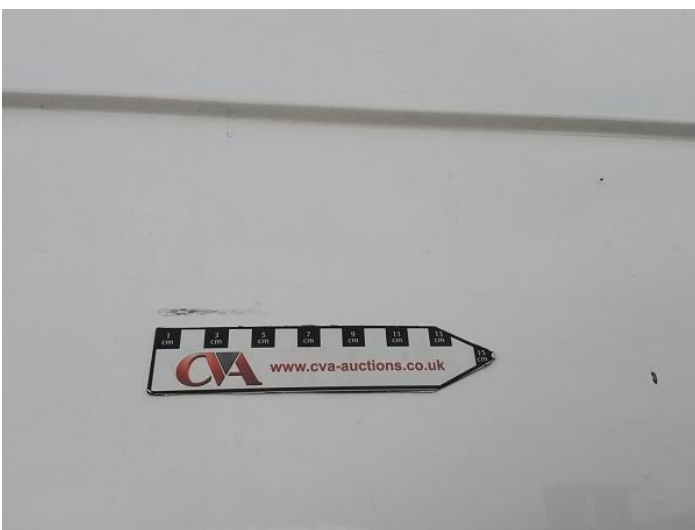
49: Qtr Panel osr  
Scratched  
Over 25mm Not Thru Paint
